CARR-1382

Wadlow Store & Dwelling
Freedom

State Historic Sites Inventory

CARR-1382
Wadlow Store & Dwelling
707 East Old Liberty Road

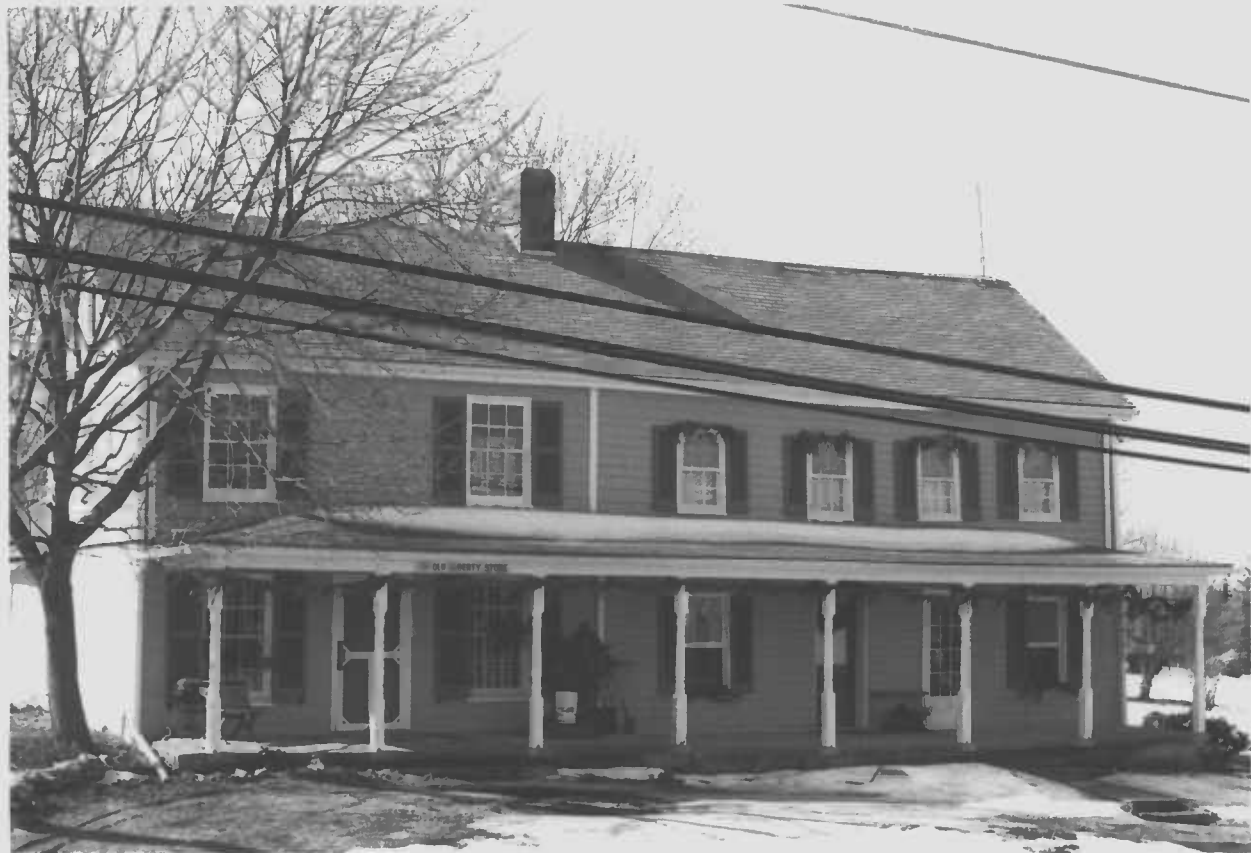
1/2

Neg. Loc.: Maryland Historical Trust
northeast elevation

The house is a two-story, four-bay by two-bay, Pennsylvania Farmhouse plan log structure with a rubble stone foundation and a gable roof with asphalt shingles and a northwest-southeast ridge. There is an interior brick chimney on the southeast end. The northeast elevation has German siding on the first story and clapboard on the second. Asbestos shingles were recently removed to reveal these materials, and the shingles remain on all the other elevations. The first story has, in each bay, a 1/1 sash in a narrow, broken-field frame that has a bevelled interior field. There is a wood sill and blinds. Those to the east are marked "V" and to the north "III". The shutter holdfasts have a cast-iron shell pattern. The east-center bay has a door with one light over one panel, and the same frame as the windows. This frame is found in the north-center bay, but the door has been replaced by later infill. The second story has four 6/6 sash with

blinds. The frames are not clearly discernable. There is a wood box cornice. There is a lightning rod on each end of the roof ridge, and they are connected by a twisted rod, with glass balls underneath it, along the ridge. There is a one-story, four-bay, hip-roof porch with a CMU foundation, a concrete deck, asphalt shingles, and four turned posts. The porch ceiling has beads on both edges of each board.

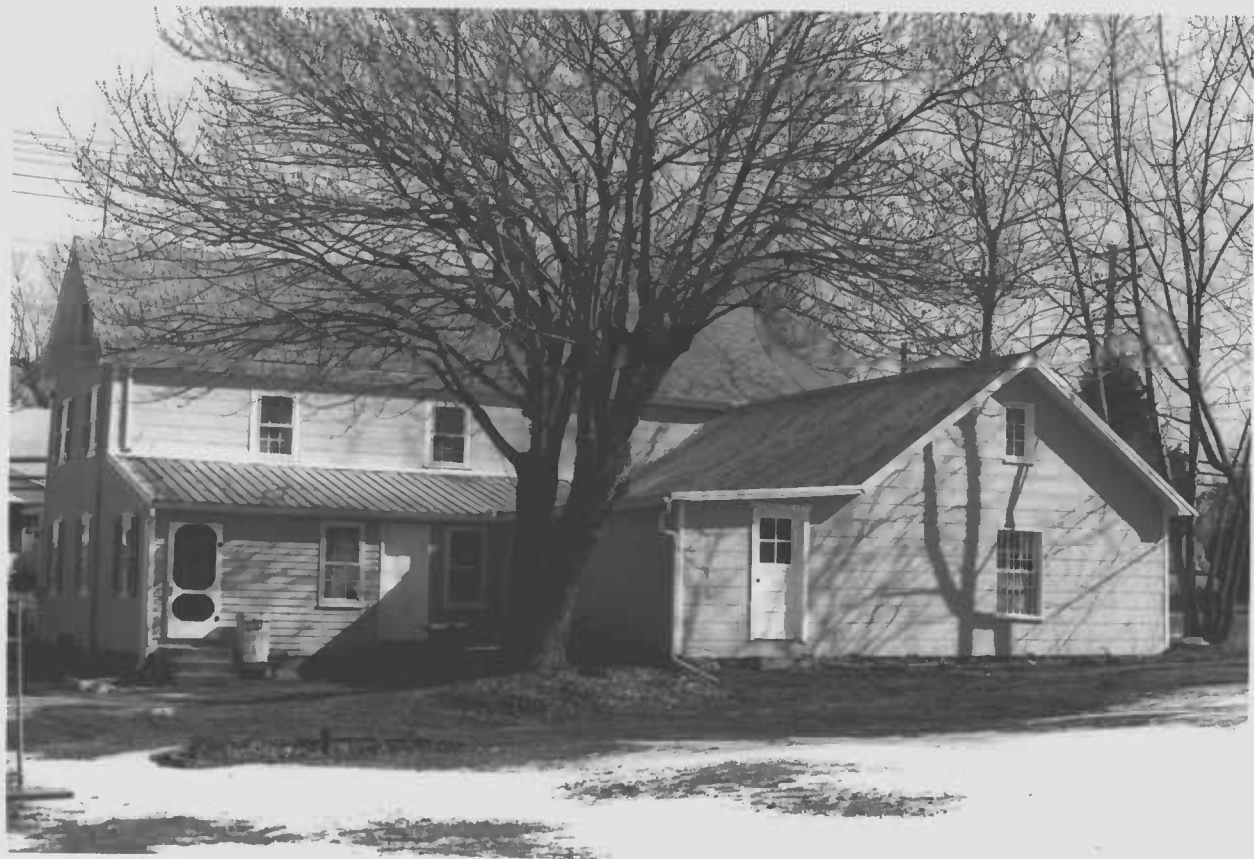
2/2

Neg Loc.: Maryland Historical Trust
northwest & southwest elevations

The northwest elevation has a large, later opening in the foundation that has two six-light sash. The first story has two 1/1 sash in frames like those on the northeast, and wood sills. The blinds are marked "VI" and "III". The second story is identical to the first, but the markings on the blinds are not visible. The gable end has the same window frames, but the blinds are closed. The southwest elevation has an enclosed one-story porch with a shed-roof that has inverted-V-seam metal. It has a concrete foundation and German siding. There are four bays, with from west to south, a four-light over two-panel door in the same frame as on the northeast; a 6/6 sash with wood sill and beaded-interior-edge frame; a four-panel door with flat, sunk panels, quirked ogee panel moulds, and a beaded-interior-edge frame; and a 6/6 sash identical to the other on this porch. The second story of the house has two 6/6 sash in wide frames that are possibly mortised and tenoned. The outer edge of the frame has an applied moulding that matches the frames on the northeast elevation.
